CONNECTICUT RIVER BASIN
GRANVILLE, MASSACHUSETTS

GRANVILLE RESERVOIR DAM
MA 00707

PHASE I INSPECTION REPORT
NATIONAL DAM INSPECTION PROGRAM

AUGUST, 1980

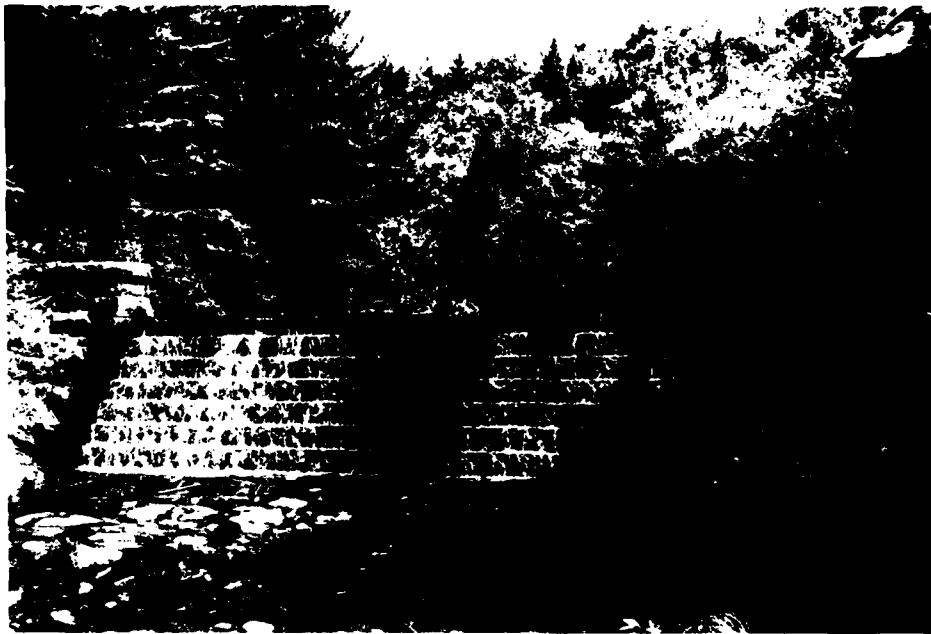
Figure 11 - Dam at Winchell Reservoir about 1500 feet downstream of Granville Reservoir Dam.
